APPENDIX 4.1-6
Land Exchange Alternative
Preliminary Geotechnical Report

Report No. 1312-02-B-3R2

Subject: *Geotechnical Review of Tentative Map, Otay Ranch Village 14 and Planning Area 16/19 – Land Exchange EIR Alternative, County of San Diego, California*

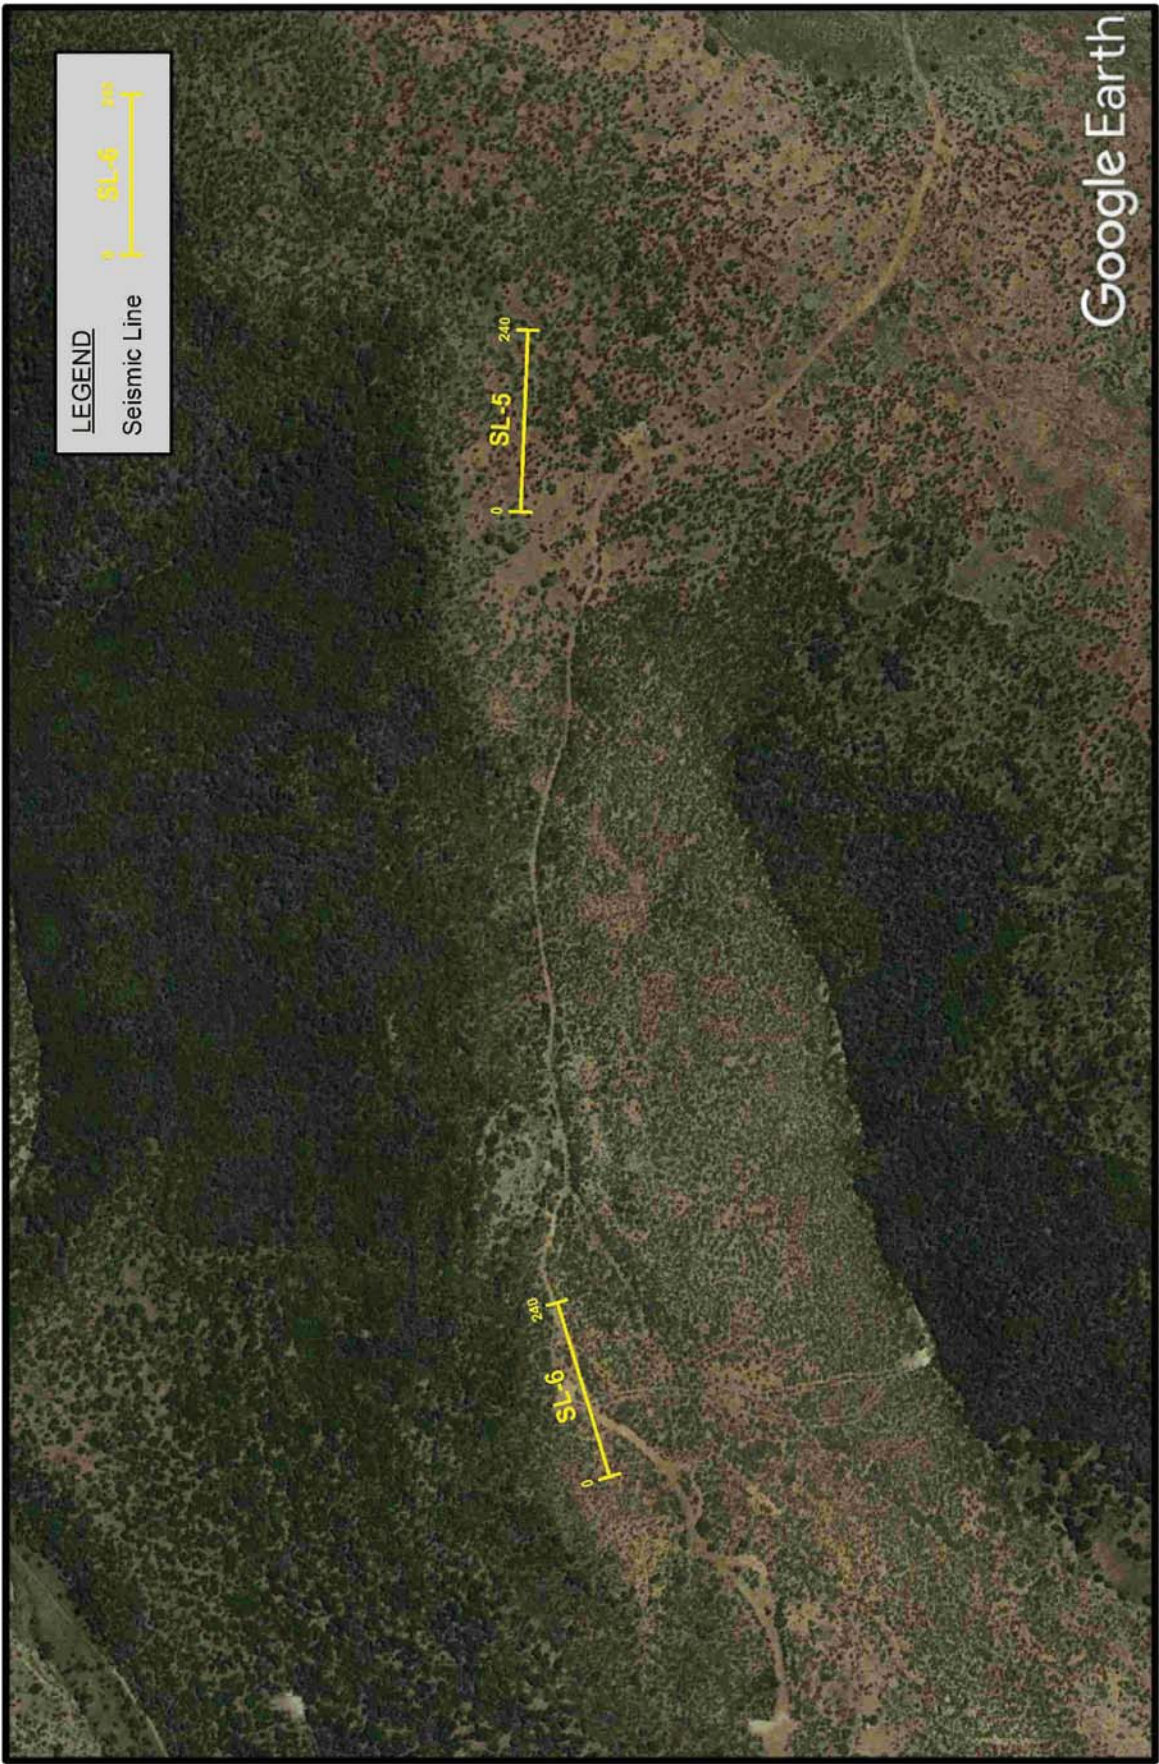
Figure 2c

LINE LOCATION MAP
(SL-5 and SL-6)
